Influence of drinking water treatment processes on the pitting corrosion of copper pipes in domestic installations

Timo Jentzsch, Angelika Becker, Ute Ruhrberg
IWW Water Centre

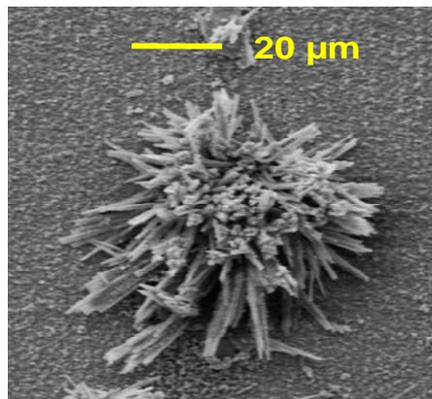
The usual formation of a surface layer on copper in hard to moderately hard waters happens by the development of micropits which are covered by malachite (Figure 1), until a closed layer exists. That means that the pits are closed with malachite caps and repassivated.

Figure 1 Microscopic picture of a malachite structure covering a micropit

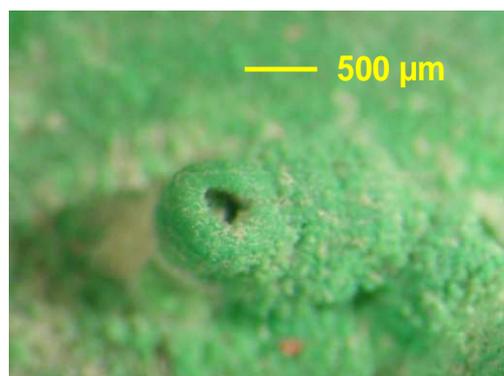
Under unfavourable conditions anodic areas develop which are covered with malachite tubercles (in softer waters with high sulphate contents with brochantite tubercles), form an isolated surface area and, according to the conditions, lead to active pitting corrosion. These areas are characterised by small channels or open tower-like structures with tunnel formation so that an exchange of material with the bottom of the pit is possible. Such a structure can be seen in Figure 2.

Figure 2 Microscopic picture of a tower-like malachite tubercle

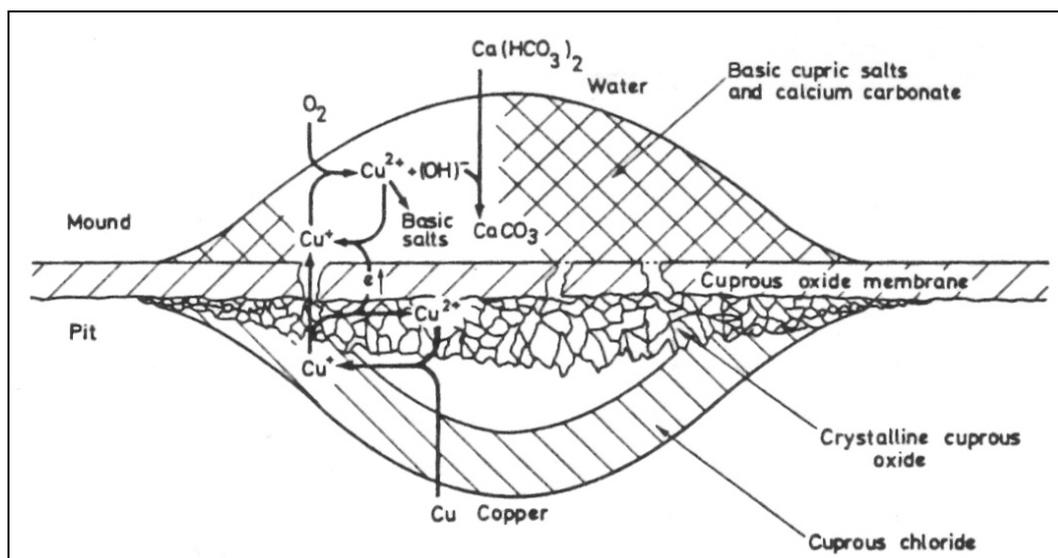
For a better understanding of the mechanism of pitting corrosion of copper and the influence of the water models have been developed. One of these is the membrane cell model by Lucey [4] which is shown in Figure 3.

Figure 3 Membrane cell model by Lucey [4]

On the inner side of the membrane Cu^+ is oxidised to Cu^{2+} (anodic reaction). These Cu^{2+} ions diffuse to the bottom of the pit and react to Cu^+ with the metallic copper. A part of these Cu^+ ions diffuses through the membrane and is oxidised by dissolved oxygen. The so-formed Cu^{2+} ions are either reduced back to Cu^+ at the cathode (outer side of the membrane) where they can also be oxidised again, or they can form basic copper(II) salts and calcium carbonate under participation of hydroxide ions from the oxygen reduction and calcium hydrogen carbonate [5].

Considering the model and the reactions involved the formation of Cu^+ and Cu^{2+} can be seen as chain reaction. This could result in a very high velocity of copper dissolution as the amount of Cu^+ formed is bigger. But the mass exchange is limited by the velocity of the electrons released to the oxide layer which is dependent on the delivery of oxygen from the water which takes up these electrons [3].

This model also has its weaknesses. The experiments which led to this model have been revised by Sosa and colleagues and they found out that more than 80% of the galvanic current flow away via the metal and not the bipolar membrane [6]. Despite these doubts about the model it serves quite well to explain the basic reactions and mechanisms involved in pitting corrosion of copper.

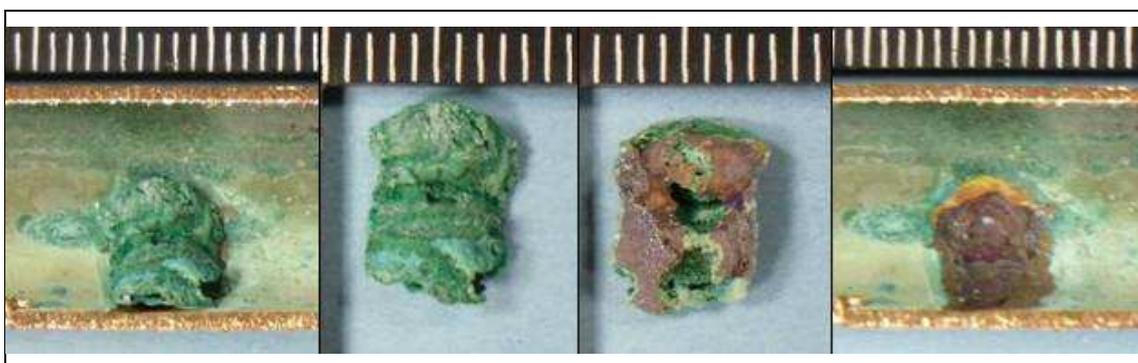
Figure 4 shows photos of a copper pipe damaged by pitting corrosion where the morphology of the attack corresponds quite well with the Lucey model.

At the level of the original copper surface the whole area of attack is covered by a layer of Cu(I) oxide, which serves as a membrane. Below this there are variable amounts of coarsely granular Cu(I) oxide and fine Cu(I) chloride. There are small pores in the oxide layer at the level of the original copper surface, while the area below the green tubercle consisting of basic copper salts shows an extensive undermining attack.

Figure 4 Photos of a copper pipe damaged by pitting corrosion

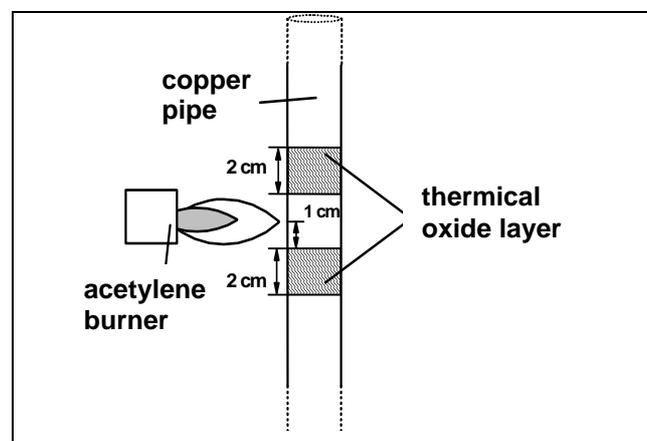
As mentioned before, hard copper pipes where hard soldering was used as the joining technique, are most vulnerable to pitting corrosion. Therefore the process of hard soldering was simulated by treating commercially available hard copper pipes with a burner similar to one which is used for hard soldering. The tip was pointed with a defined distance and for a defined time at a slowly rotating pipe to obtain equal heat distribution around the whole pipe diameter in the respective areas. In this way each pipe is prepared with four heat affected zones. This procedure is schematically shown in Figure 5.

Figure 5 Process of heat treatment (schematically)

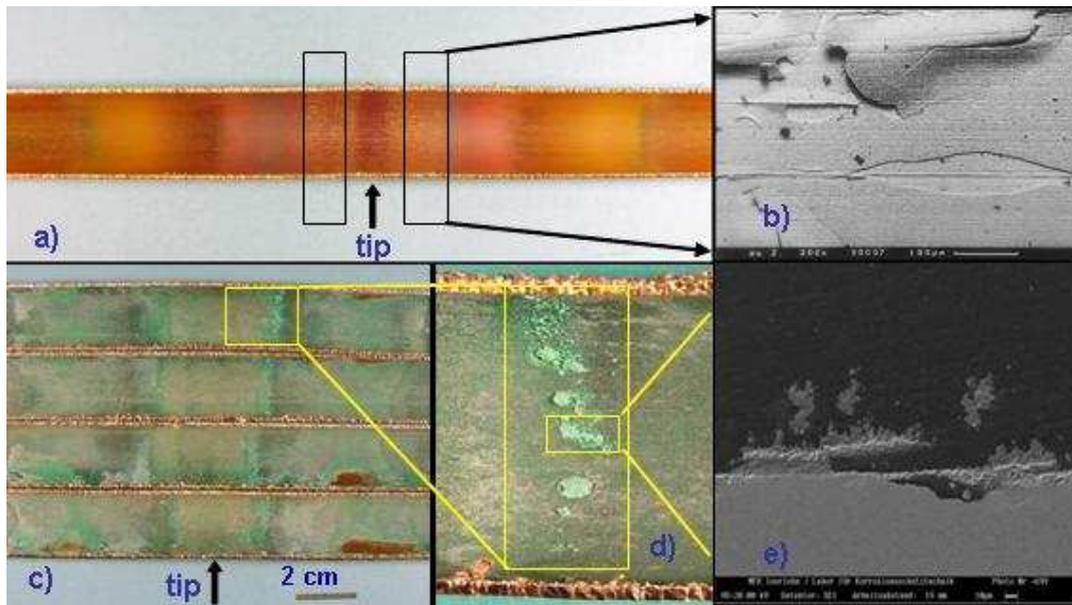
Figure 6 gives some insight into copper pipes prepared in this way.

Figure 6 Copper pipes after preparation by simulated hard soldering

Picture a) of Figure 6 shows a horizontally sliced copper pipe after heat treatment. The black rectangles show the areas where pitting corrosion is most likely to occur. They begin approximately one to one and a half centimetres left and right from the point where the tip of the burner was, and reach out about one and a half centimetres further. A scanning electron micrograph of a heat treated area is shown in b), where the defects in the thermal oxide layer are clearly visible. The three pictures at the bottom of Figure 6 give an example what the inside surfaces of the heat treated pipes can look like after exposition to different waters. In picture c) one can see the areas around the tip where numerous corrosion tubercles have developed (yellow rectangle). A detailed sight of this area is given in d), while e) is a cross section of it showing the pit under the tubercle.

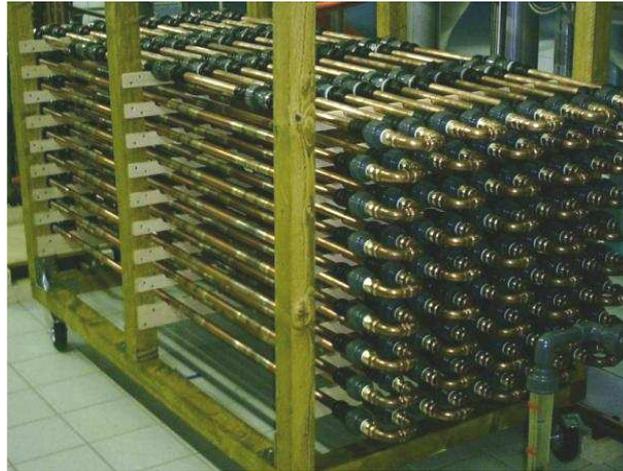
The exposition of the prepared pipes to the different waters of interest is done by placing them in a test rig with multiple strings so that different water compositions can be compared. The test rigs are operated with a defined program of flow and stagnation to simulate the usual flowing conditions of water from a domestic installation. An example of a test rig installed in a water treatment plant is given in Figure 7.

Figure 7 Test rig for the investigation of the copper surface and pit morphology

After certain time intervals (often several weeks) one pipe of each string is taken from the test rig for investigation. The pipes are sliced horizontally and the surfaces are documented by photography.

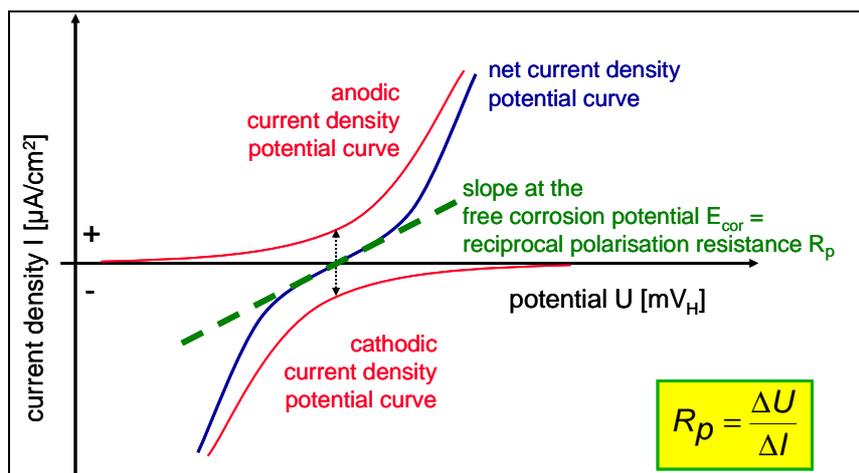
As indicated in the introduction, corrosion reactions are of electrochemical nature. Charge carriers, meaning electrons and ions, are continuously passing through the phase boundary, resulting in measurable currents. Their extent is determined by the electrical resistance at the phase boundary. An established method is the recording of current density potential curves. A first step would be the determination of the free corrosion potential, without a current applied to the system. It characterises the driving force of the corrosion reaction under comparable conditions. The actual method of recording current density potential curves is based on the application of a continuously increasing direct current in an appropriate test arrangement which results in a measurable change in the potential. This method is called galvanodynamic polarisation. By plotting these values one gets the current density potential curves (Figure 8).

Figure 8 Current density potential curves (schematically)

Galvanodynamic polarisation shifts the potential either in anodic (positive) or in cathodic (negative) direction so that every potential value can be associated to a current value, resulting in a curve. The anodic corrosion processes accord to the anodic partial current density potential curves while the cathodic corrosion processes accord to the cathodic current density potential curves. These curves can be combined to a net current density potential curve. At a certain point, the anodic and cathodic current, respectively, are equal so that no current is measurable. Therefore this point is called the free corrosion potential. Often the current density is plotted logarithmically (Tafel plot), which results in a reflection of the cathodic partial curve along the x-axis into the positive region. Thereby so-called Tafel-slopes can be determined which probably show linear areas [7].

The shift of the potential enables to derive the development of the driving force of the corrosion reaction from the associated current density. A high current density represents a high degree of material conversion, meaning a high corrosion velocity. Thus the inhibition of the activities of the respective partial reactions can be assumed from the steepness or flattening of the curves.

As indicated in Figure 8 the slope of the net current density potential curve at the free corrosion potential is a direct measurement for the sum of all resistances of the complete system. The reciprocal slope equals the polarisation resistance R_p which characterises the relative change of the complex resistance system. R_p is directly proportional to the corrosion resistance of a complete corrosion system.

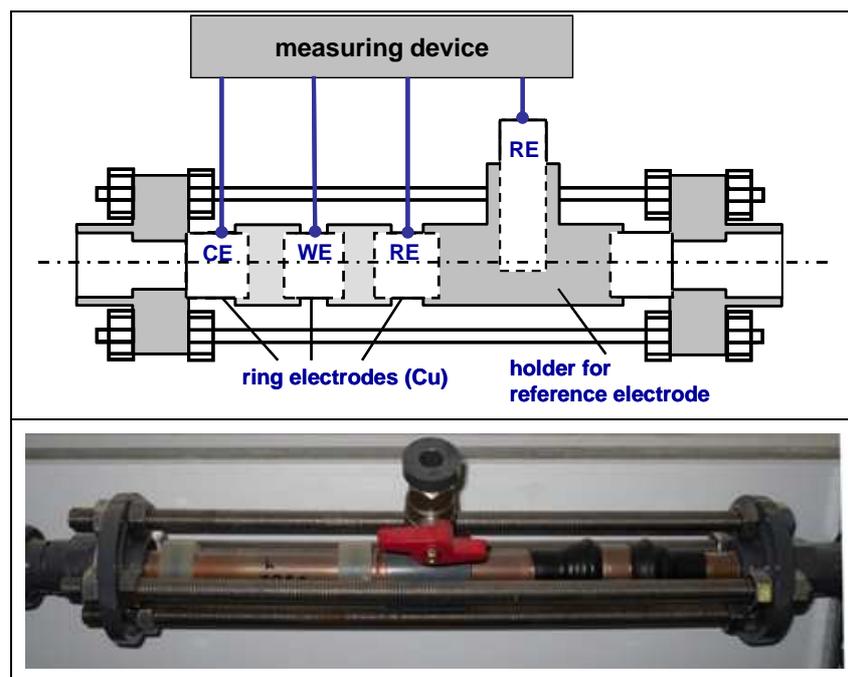
Electrochemical tests in this work were done by the use of self-developed ring columns. They consist of a variable number of rings made of the material of interest (here: copper), separated from each other by plastic spacers. All these pieces are, including a holder for the reference electrode, pressed together with PE-flanges and thread rods (see Figure 9). This column can be installed in a test rig or even in a real installation (via bypass). Water can flow through it like through a pipe and measurements can be conducted by an appropriate test arrangement.

Figure 9 Ring column for electrochemical tests; top: schematic;bottom: practical realisation

The electrochemical test arrangement consists of the classical three-electrode-set-up. One copper ring serves as the working electrode where the current is applied. A silver/silver chloride electrode is installed in the holder for measuring the potential and a second copper ring serves as counter electrode to close the electrical circuit. In special cases the third ring electrode may be used as a reference electrode, too.

The electrodes are connected to a potentiostat. This device is the current source on the one hand and the measuring instrument on the other hand. It is connected to a notebook which collects the data and plots it with special software.

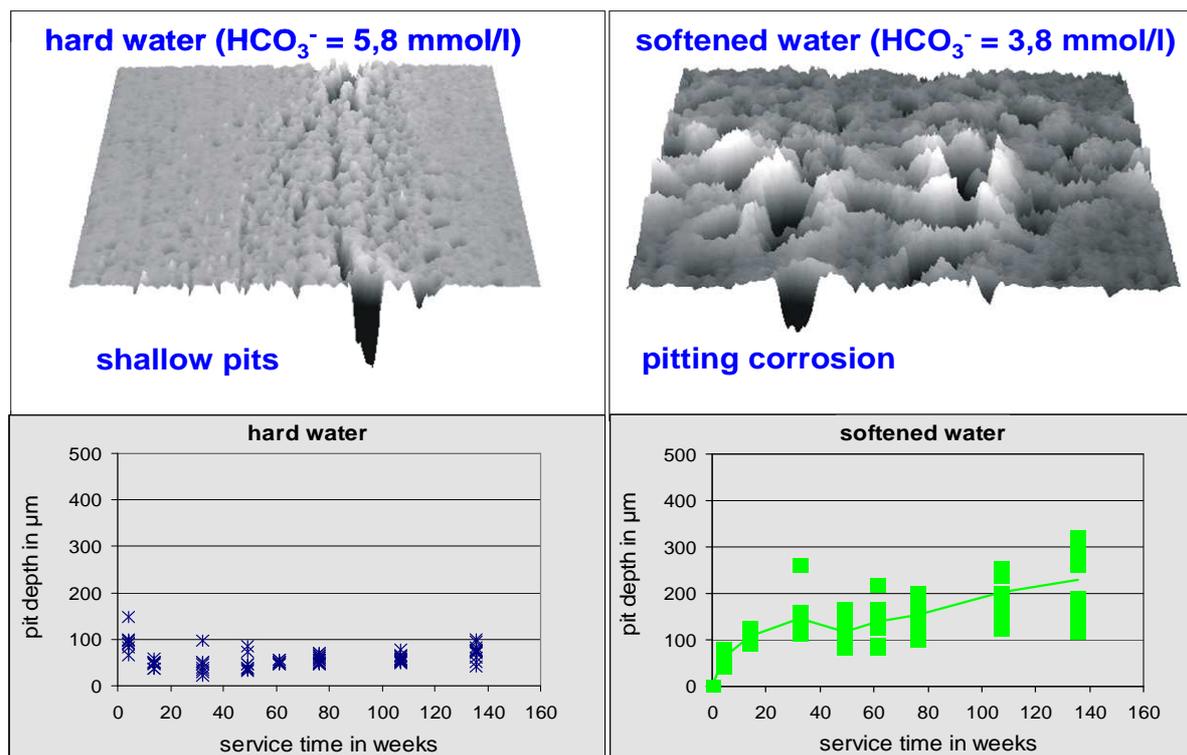
The heat treated copper pipes installed in the test rig were investigated according to surface appearance and pit morphology as well as pit growth. The aim was to show the influence of chemical softening of a hard groundwater with a relatively high neutral salt content on the pitting corrosion behaviour of copper. In Figure 10 the topographies of the respective copper surfaces and the distribution of the deepest pits for the water before and after softening are compared. The left hand part shows the results for the hard water, the right hand part for the softened water. In the lower graphics the maximum pit depth (in μm) is plotted against the service time of the respective pipe (in weeks).

Figure 10 Comparison of surface topography and pit growth on copper in two different waters

Figure 10 clearly indicates that the softening of the water had a detrimental effect for the copper pipes as it activated pitting corrosion. While the hard water only caused shallow pits not increasing significantly in depth over time (indicating repassivation) the softened water showed active pitting corrosion with increasing pit depths over time. This results support the theory that the removal of the buffering agent hydrogen carbonate may promote pitting corrosion.

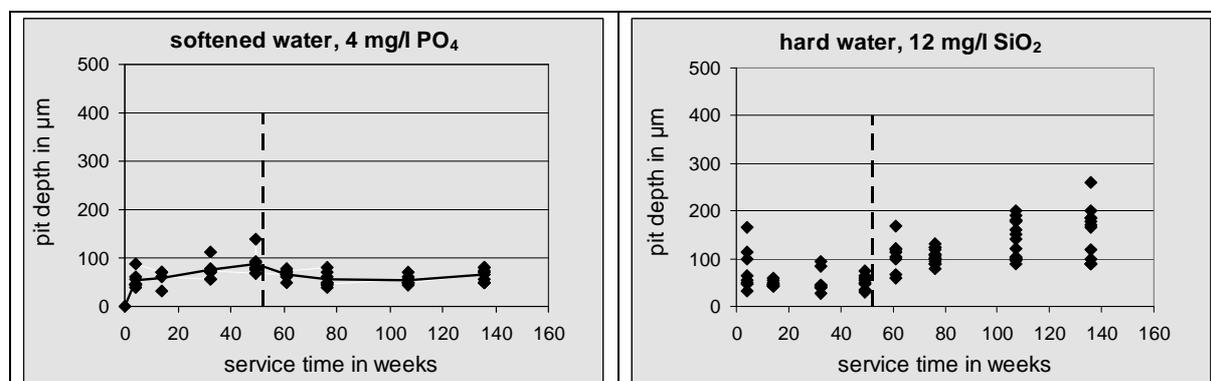
In the same project, also the effect of different corrosion inhibitors has been investigated. Two graphics, similar to those in Figure 10, were chosen to introduce the most interesting results. They are presented in Figure 11. The left hand part shows the influence of the dosage of a mixed phosphate inhibitor (ortho- and polyphosphate) to the softened water and the right hand part shows the influence of the dosage of a silicate inhibitor to the hard water. The dashed line denotes the dosage starting.

Figure 11 Results for the dosage of different inhibitors

The two graphics of Figure 11 show that the dosage of the different inhibitors to the different waters has somehow reversed the respective effects which were shown in Figure 10. The phosphate inhibitor in the softened water led to repassivation of the active pitting corrosion which occurred without it. On the other hand the silicate inhibitor seems to have activated the repassivated shallow pits which occurred in the hard water before.

These results indicate that it is important to know if the inhibitor which is planned to be applied can really inhibit pitting corrosion or if it even can worsen the problems like the silicate inhibitor in this case. Therefore tests like those presented here should be carried out in advance.

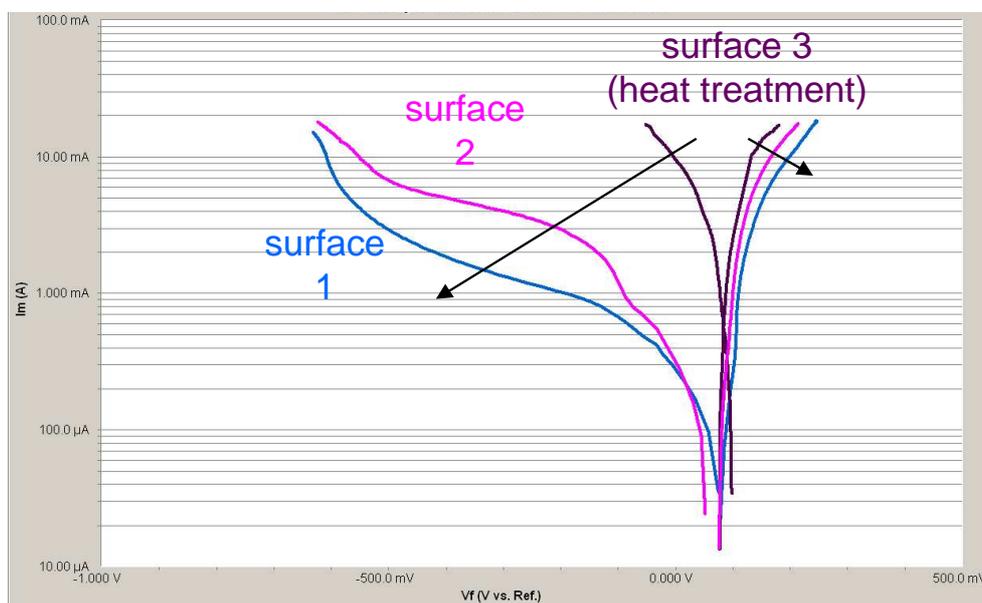
In Figure 12 the scans of three different surface conditions of copper in the same water are compared. One of the pipes had received a heat treatment before testing.

Figure 12 Galvanodynamic scans of three different surface conditions of copper in the same water

It can be recognised that the different surface conditions can be elucidated quite well using the technique of galvanodynamic polarisation. This electrochemical technique is based on slightly disturbing the corrosion system at the phase boundary between material and corrosion medium using small amounts of direct current. The magnitude of the resulting potential shift depends among others on the consistency of the inner surface of the copper pipes directly at the phase boundary.

The more significant effect can be seen at the cathodic partial reaction, while the differences at the anode are only marginal. This indicates that the inhibition of the corrosion process in the initial phase is mainly a result of the properties of the copper oxide layer serving as cathode.

The graphic underlines that the prior heat treatment of one of the pipes leads to the most active surface compared to the two other ones. This is due to the defects in the copper(II)-oxide layer caused by the heat treatment. This can be seen in the steepness of the curve.

In contrast to that the two other copper pipes without heat treatment, which have a relatively homogenous surface, result in much flatter slopes of their respective cathodic curves. That means that these surfaces are less active than after a heat treatment.

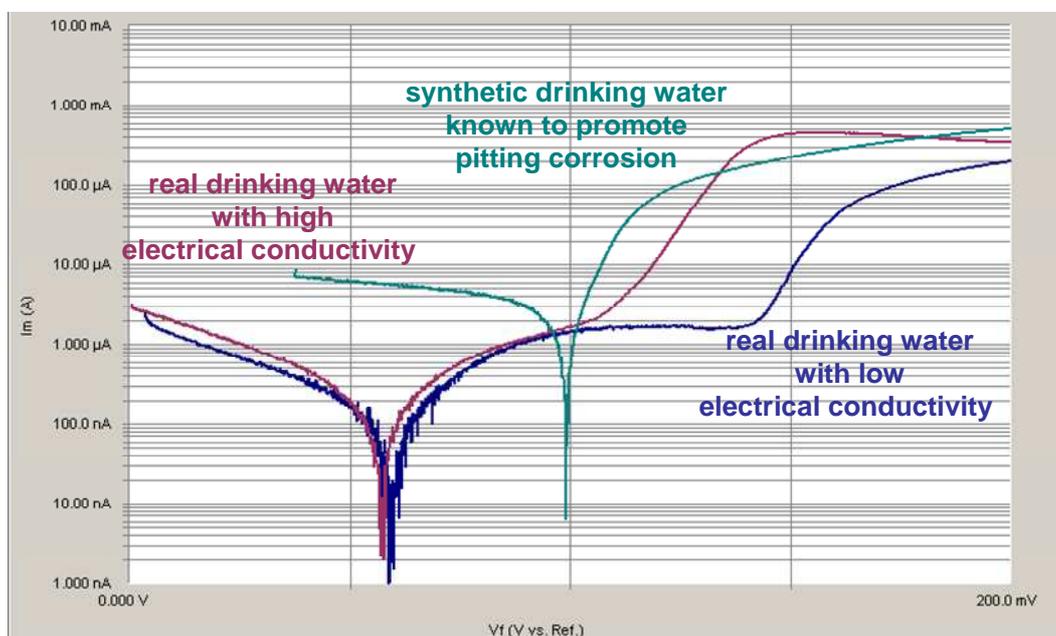
Figure 13 presents some results of laboratory-scale electrochemical tests. In these experiments a piece of a copper pipe was immersed in the water of interest. Potentiodynamic scans were performed here which means that the potential of the copper was changed with a very slow scan rate while the corresponding currents were measured. The graphical presentation of the results is the same as for the galvanodynamic scans.

Figure 13 Results of potentiodynamic scans of copper pipes with comparable surface conditions (primary oxide layer) in different waters

Aim of these investigations was the determination of the pitting potential as the critical potential, where pitting corrosion begins to occur [8]. Therefore the anodic polarisation was of the preferring interest.

The anodic parts of the curves of the two real drinking waters show a significant passive area, meaning the area where the current is not increasing. When the current starts to increase again, the systems pass into the active state. At this transition between passive and active the pitting potential can be estimated. In this case the lower electrical conductivity of one of the waters caused a shift of the pitting potential towards more positive values which indicates that this water is less pitting promoting towards hard copper pipes.

The curve of the synthetic drinking water which was known to promote pitting corrosion showed a completely different behaviour. The free corrosion potential was shifted significantly towards more positive values and the system passed directly into the active state. That indicates that the pitting potential is very close to the free corrosion potential and thus it is reached much easier and faster.

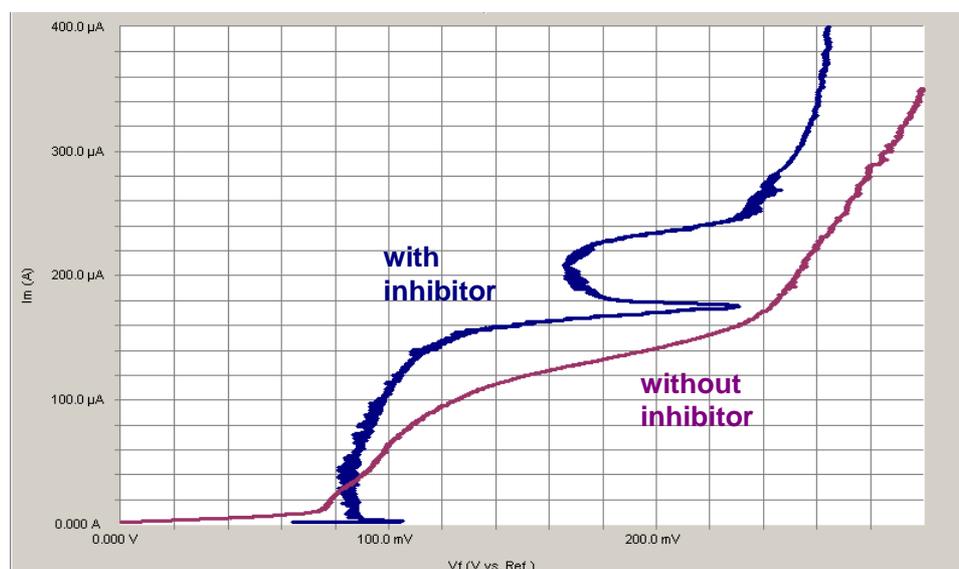
Another electrochemical method used for these investigations was the application of galvanodynamic scans in laboratory-scale tests. The set-up was equal to the potentiodynamic polarisation tests mentioned before, but here the current was altered and the potential was measured, as described for the ring column tests. The surfaces of the copper pipe sections used here have been pickled before the tests to gain equal initial conditions. Figure 14 shows a set of curves showing the development of the potentials of two equal copper pipe sections, one of them exposed to a middle-hard water and the other one to the same water after the addition of a corrosion inhibitor.

Figure 14 Results of galvanodynamic scans of equal copper pipes in different waters

The curves are plotted again with current (non-logarithmic) against potential. Looking at the red curve of the water without inhibitor, one can see that the potential is almost steadily increasing with increasing current. At the point where the curve gets steeper the pitting potential can be estimated. Contrary to that the blue curve representing the water with inhibitor has a completely different run. The free corrosion potential was shifted significantly towards more positive values and in this curve there can be seen a distinguished point where the potential decreases again. This indicates a repassivation of pitting caused by a modification of the surface layer morphology. A further increase of the current then induces active pitting corrosion, which is represented by the re-increase of the potential.

These results show that this method can also be used to compare the influence of different waters on the pitting corrosion behaviour of copper pipes.
